F-3-71
Devilbiss-Whitmore Farmstead
Lewistown vicinity
Private

F-3-71
Devilbiss-Whitmore Farmstead
Lewistown
Frederick County

historic Devilbiss-Whitmore Farmstead

street & number 8702C Links Bridge Lane not for publicationcity, town Lewistown x vicinity of congressional district 6th

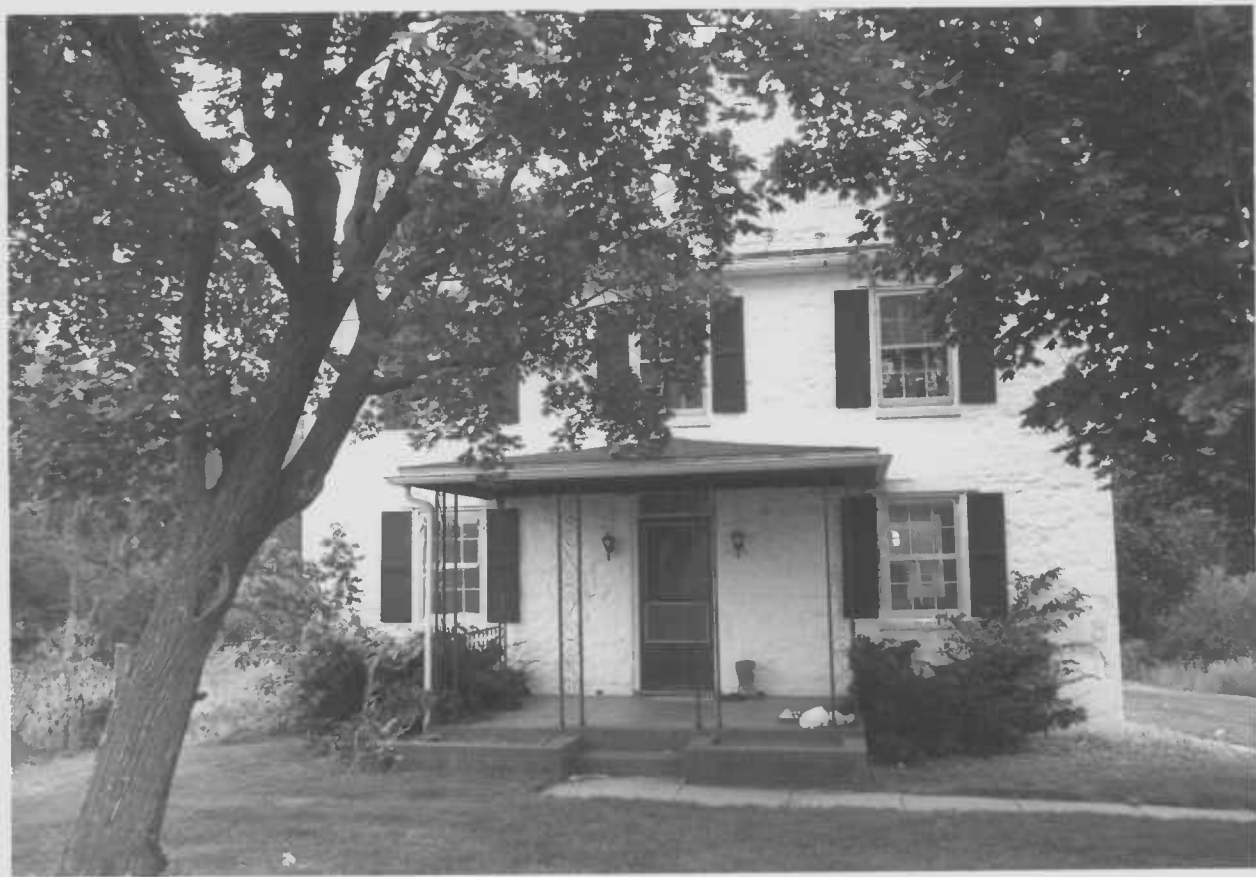
1/6

West elevation

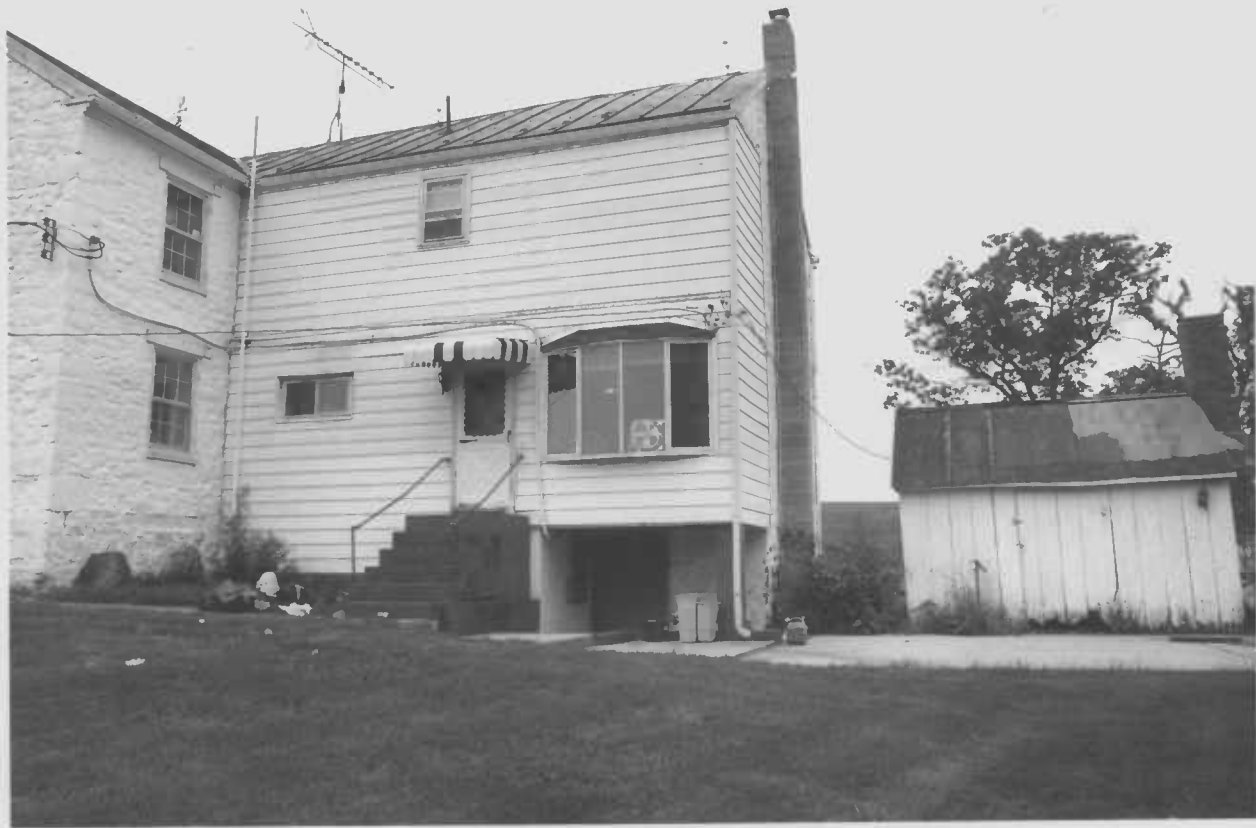
2/6

Summer kitchen: The summer kitchen is a one-story rectangular structure located immediately east of the rear wing of the dwelling. It is covered with white-painted vertical siding of wide flush boards and may have log structure under the siding. A vertical board door is located in the south elevation and an exterior brick and stone chimney is located at the east gable end. The roof is covered with corrugated metal. The building was possibly built about the same period as the house, as similar structures are common on farmsteads of the first and second quarters of the 19th century, and frequently on later farmsteads.

Rear wing and summer kitchen, view from south-
east

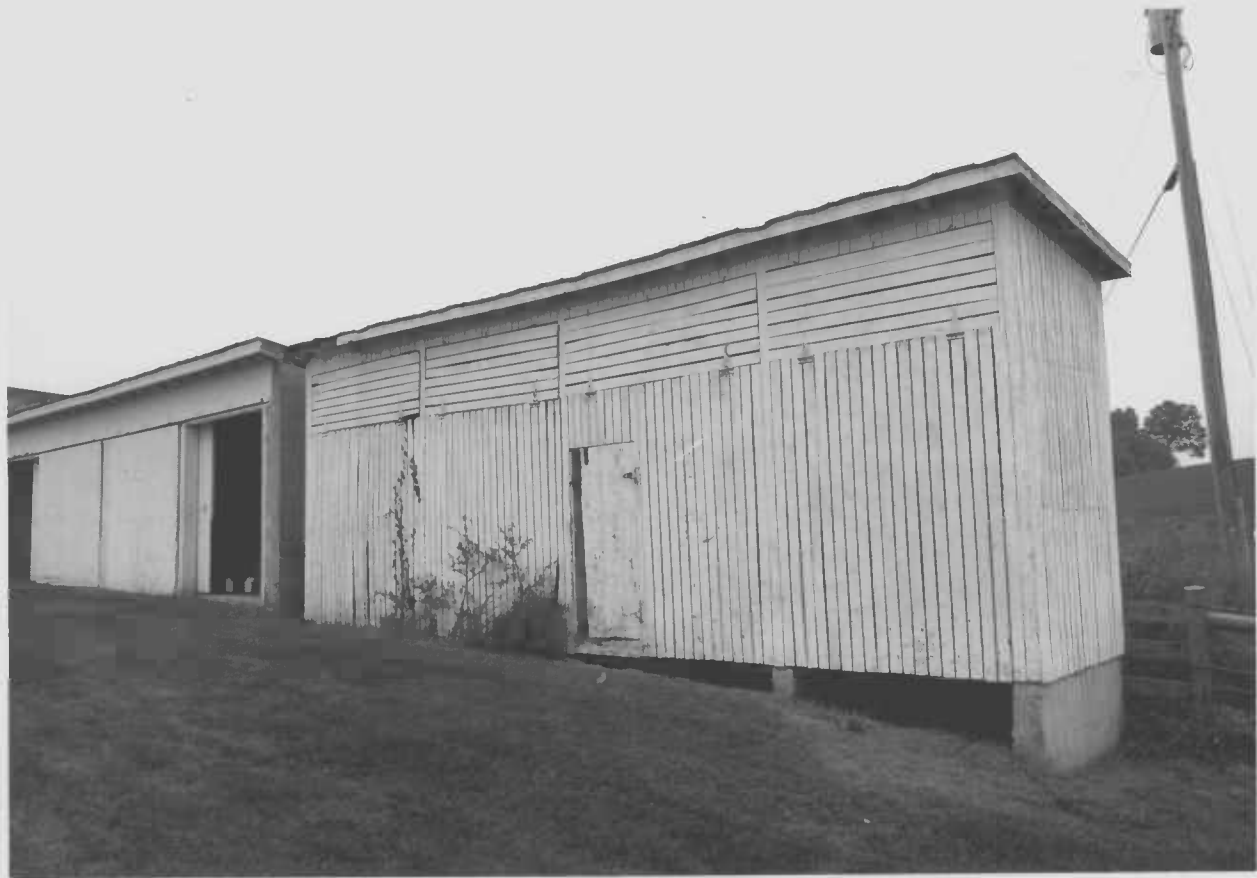
3/6

Corn crib: A frame, free-standing corn crib is located west of the house next to a non-contributing concrete block equipment shed. Built about 1900, the rectangular structure has horizontal open lath structure with three bays marked by dropped doors near the top of the crib for loading. The roof is a standing seam metal shed sloped toward the north. Although most corn cribs of the late 19th and early 20th century were part of a wagon shed, a few of the free-standing type such as this remain standing. Its location may have been shifted within the agricultural group, as the light structure renders the building type almost portable. The crib may have been moved to this location after the construction of the equipment shed, about 1945-50.

Neg. loc.: Md. SHPO, Crownsville Md
Fair crib. view from east

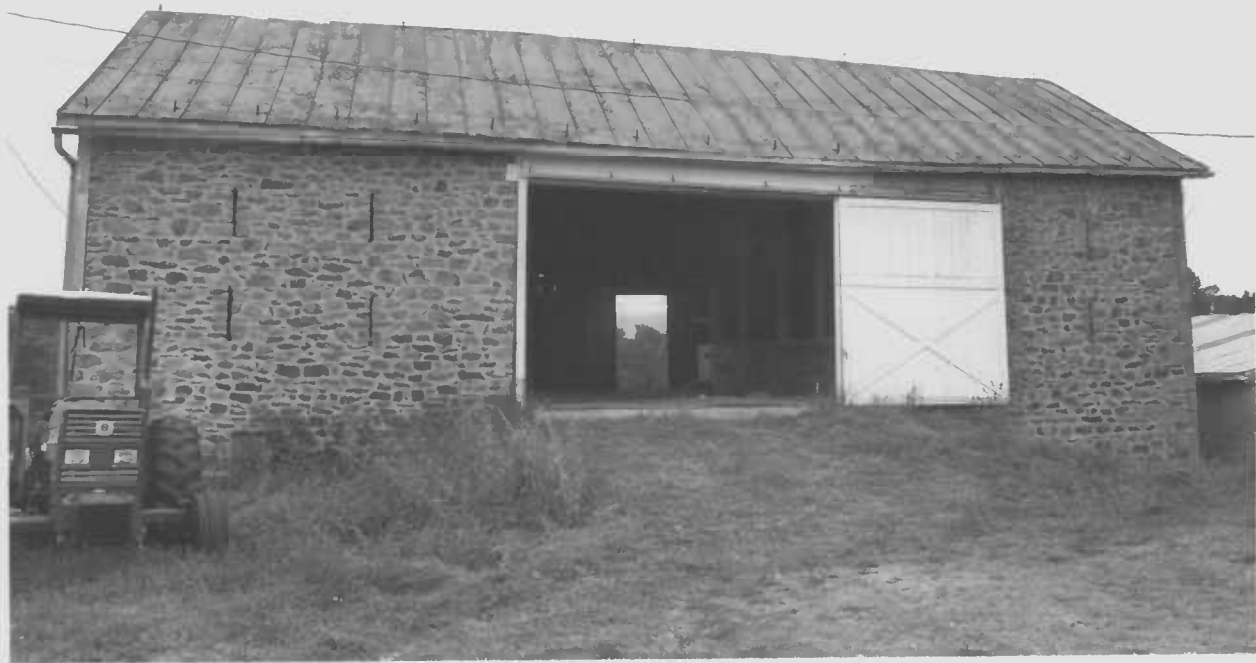
4/6

Stone barn: The stone bank barn is located southwest of the house and appears to have been built originally about the same period as the house, but has had considerable rebuilding, especially in the interior framing and the south gable end,

Bank born, west elevation

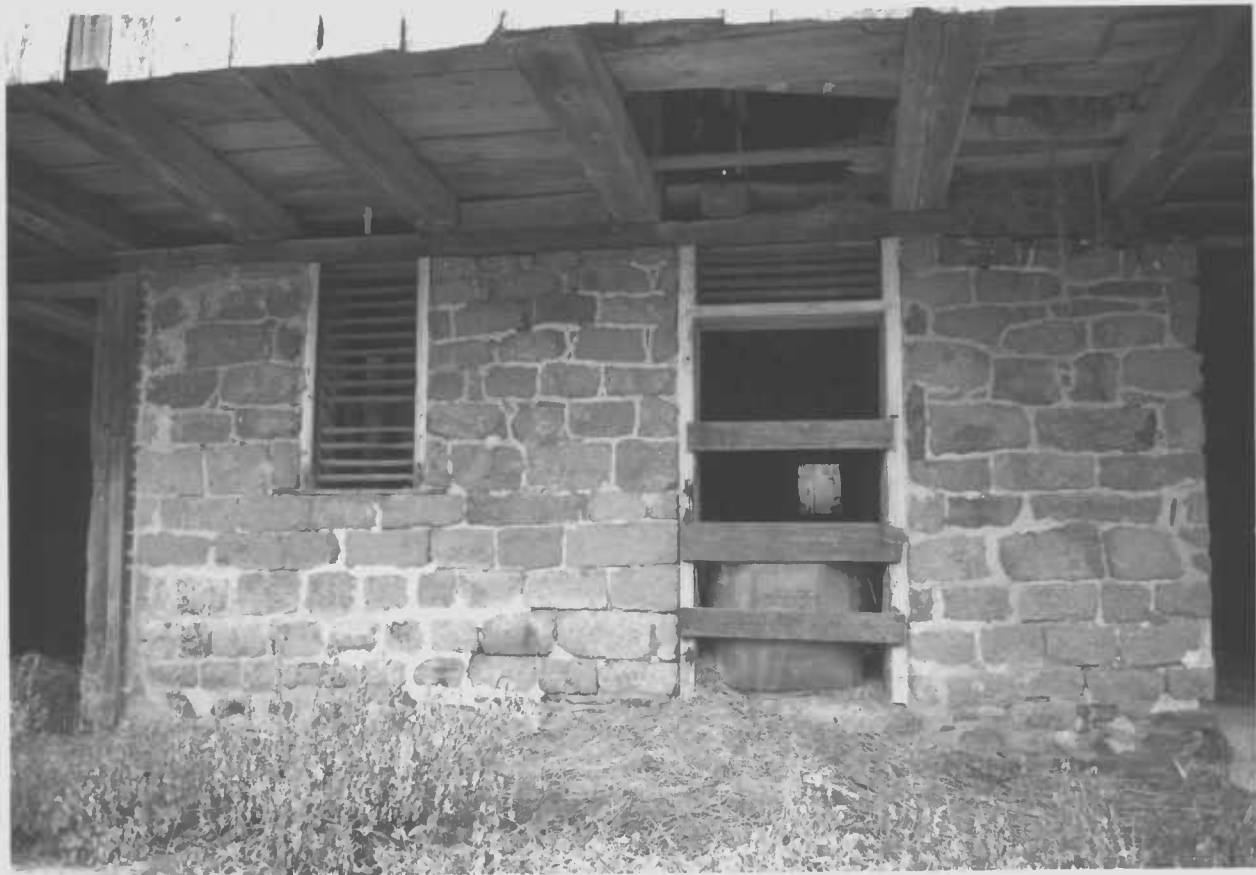
5/6

where a modern concrete block wall has replaced the original stone. The forebay on the east elevation has vertical siding. The stall level is enclosed by a carefully cut stone wall, rather than the more random rubble walls of other barns of the 19th century which have stone enclosures of the stalls. The aisle openings have been widened during the early 20th century and later, and infilled with concrete block and brick at the new jambs. At the north end of the stall level is an arched entry. The north elevation of the barn has a metal covering over the gable section of the wall. The west elevation has narrow vertical vent openings in the wall and sliding doors over the entrance at the top of the ramp. The interior framing appears to date from about 1890. The roof is both standing seam and corrugated metal. Modern non-contributing loafing sheds in concrete block extend eastward from the north and south ends of the barn, and are connected by roofed open sheds.

Detail, bank barn stonework, east elevation

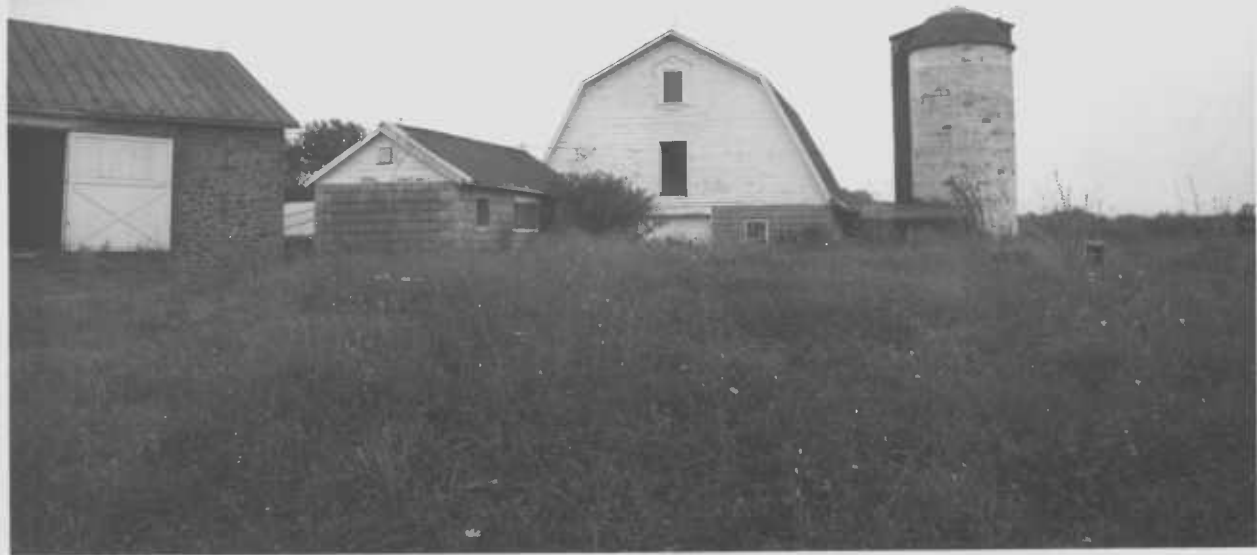
Dairy barn and milk house: The rusticated concrete block dairy barn is located west of the stone barn. It appears to have been built about 1920-1930, during a period when many barns of the same design appeared on farms throughout the county. The upper frame structure is covered with german siding and the roof is gambrel with standing seam covering. The concrete block has corner quoins. The gable window in the north elevation has scroll-sawn decorative trim. The milk house was built at the same time just north of the barn. It has similar materials as the barn, but with a gable roof. The sash in both buildings is metal industrial sash. A non-contributing concrete block silo is located west of the dairy barn.

Dairy barn and milk house, north elevation
6/3
